NAVAL POSTGRADUATE SCHOOL
Monterey, California

A CASE STUDY OF THE USS *DWIGHT D. EISENHOWER*
COLLISION AND ITS IMPLICATIONS

Patrick J. Dennison

September 1993

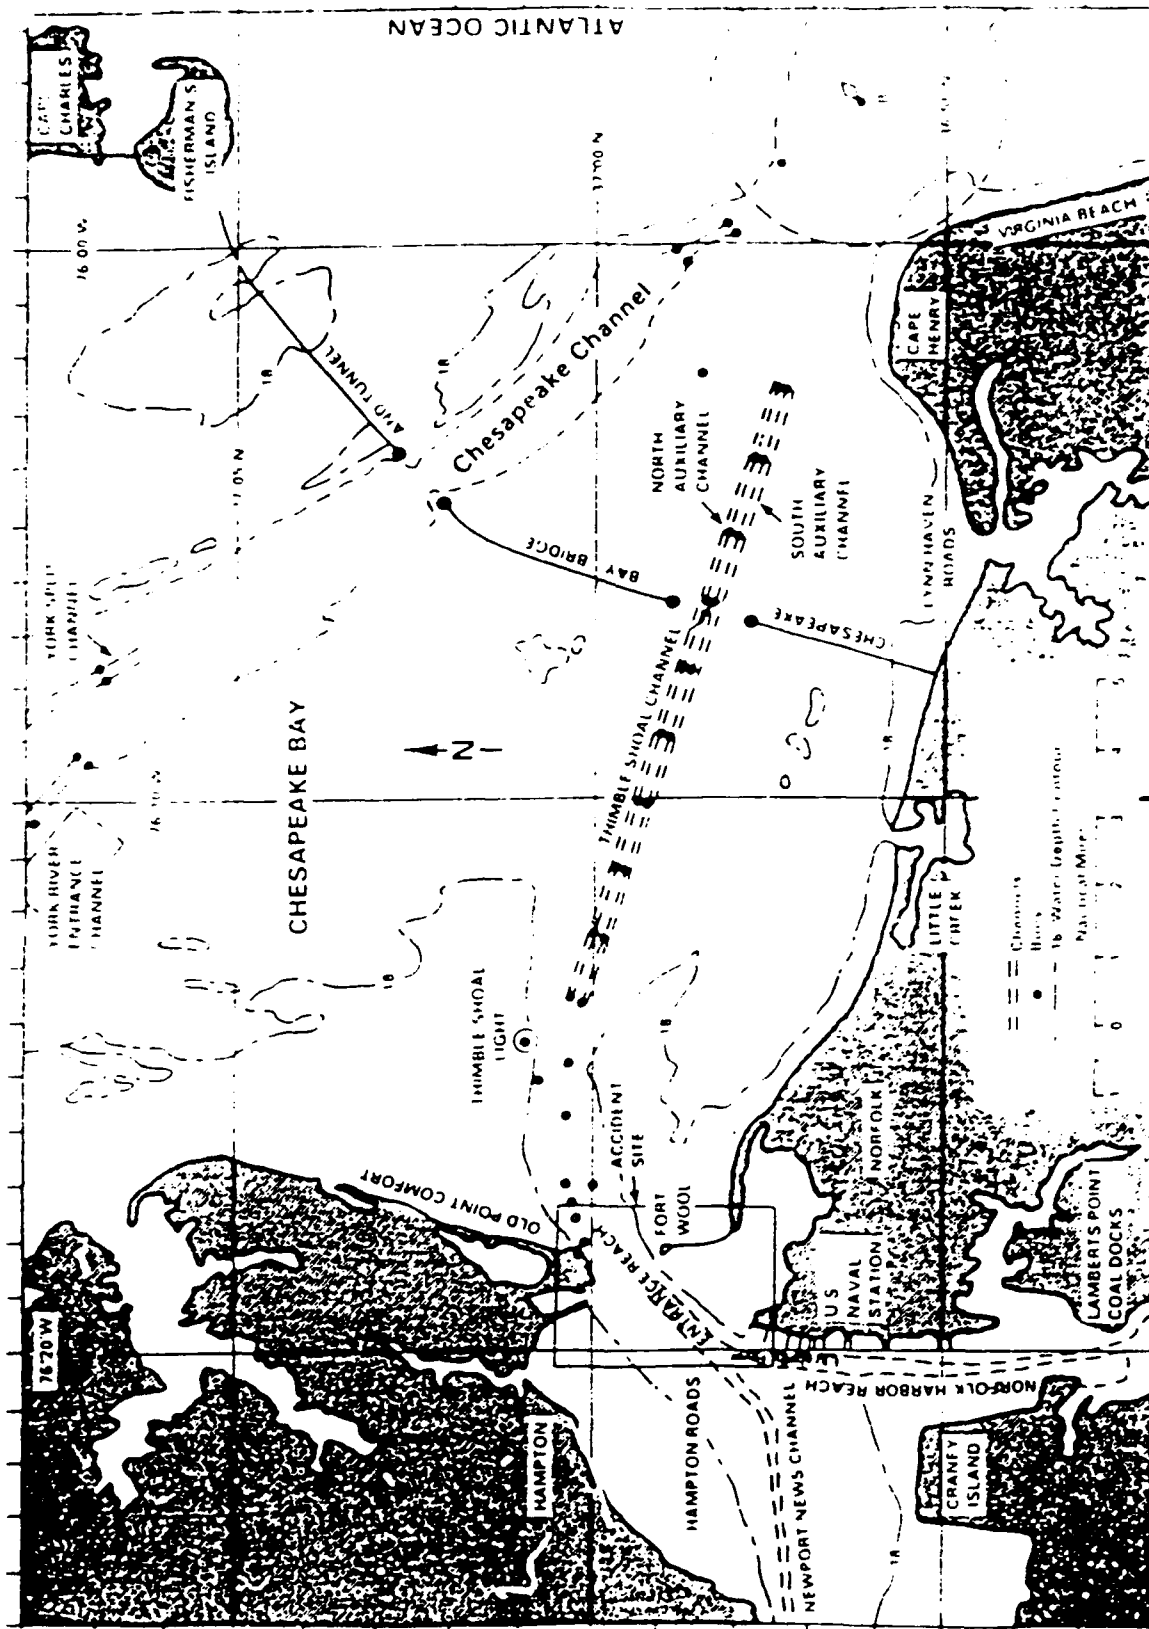
Figure II-1. Chart of the accident site

On 29 August 1988, at approximately 0821, the USS DWIGHT D. EISENHOWER (CVN 69) collided with the Spanish bulk carrier, URDULIZ. The EISENHOWER was returning from her first extended deployment in almost three years, and was transiting the recently narrowed Entrance Reach Channel. The EISENHOWER sustained over two million dollars damage to her number 2 aircraft elevator and along the starboard side where the impact took place. The URDULIZ damage totalled over 350 thousand dollars and was confined to the bow. There were no injuries to personnel on either ship, nor did the collision render either ship unseaworthy. [Ref. 2:p. v] Figure II-1 displays a chart of the accident site.

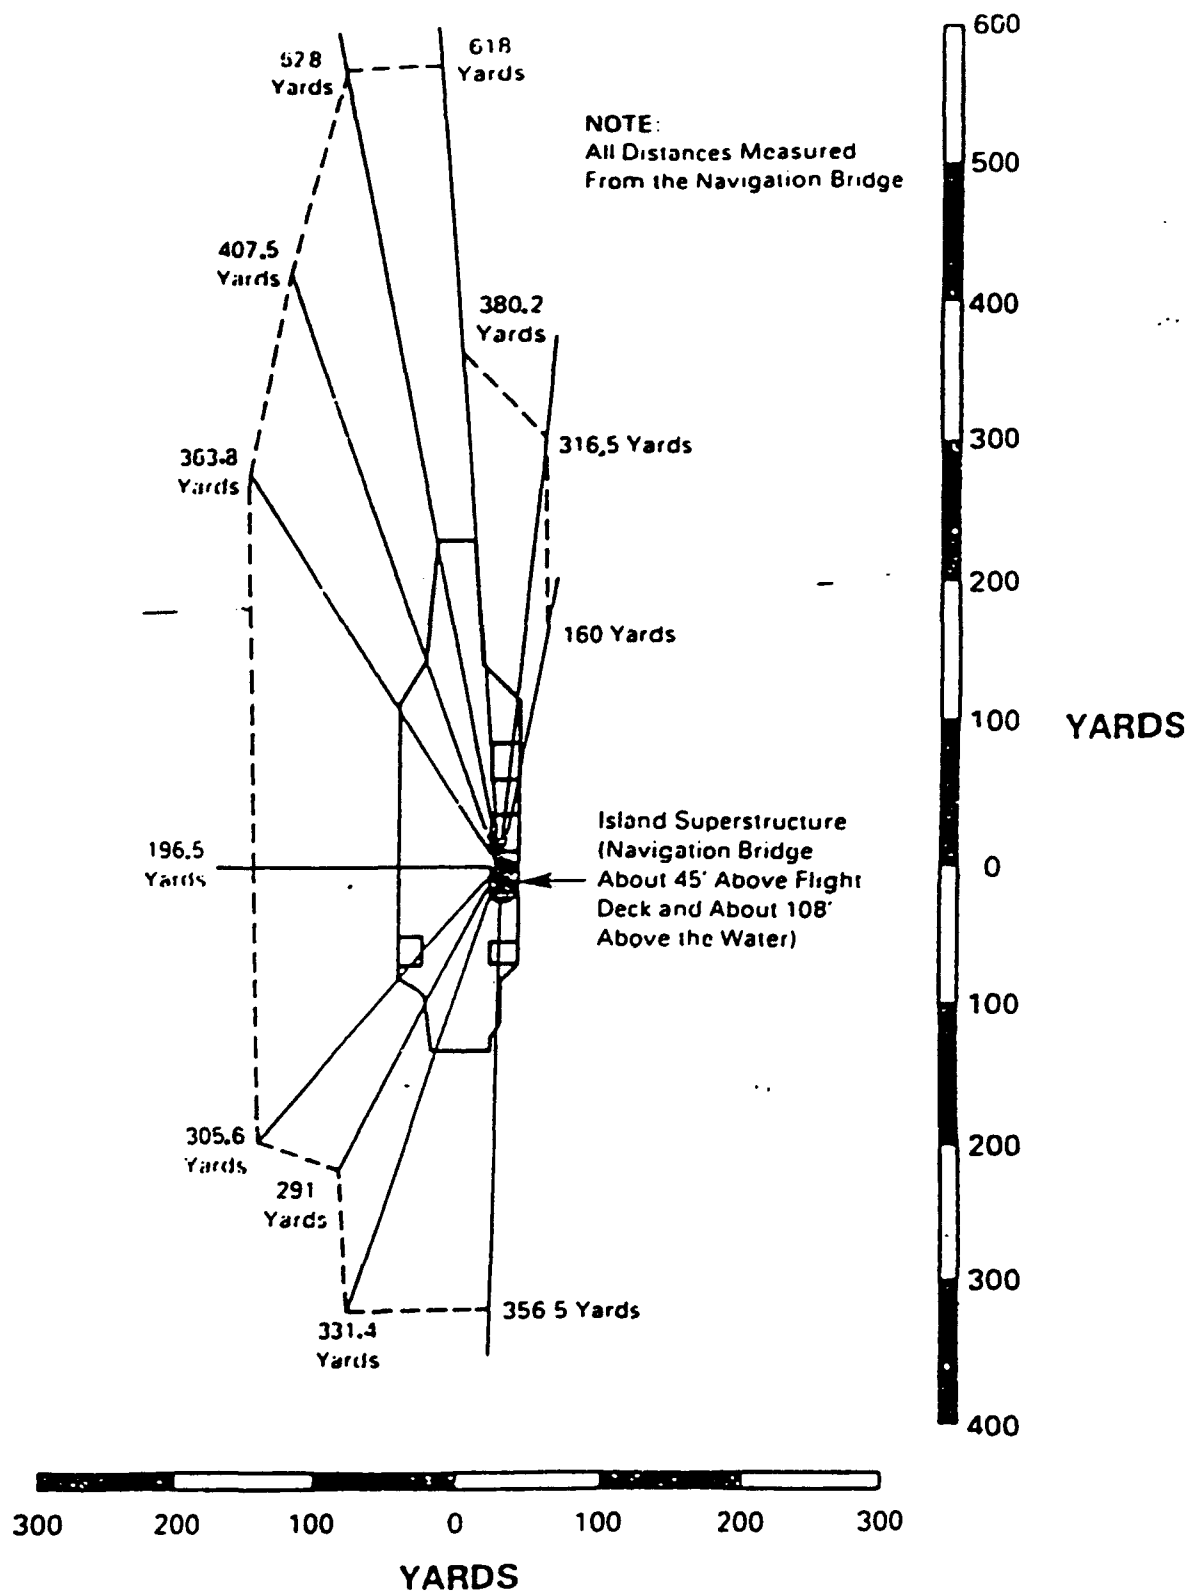
Figure III-2 Shadow zones measured from the bridge of the EISENHOWER

This is particularly important because of the *EISENHOWER*'s "shadow zones" and her 36 foot draft. The shadow zones created by the *EISENHOWER*'s size are depicted in Figure III-2. The inability of the bridge team to continually monitor the port-to-port passage of the *LIPSCOMB* factored in the collision. According to the investigation,

If the *EISENHOWER* had followed its planned track, with its bridge on the northern edge of the old Entrance Reach Channel (700 feet wide at buoy 1ER after the changes) its flight deck would have "shadowed" approximately 590 feet of channel on its port beam, leaving about 110 feet of the channel visible from the navigation bridge to buoy 1ER and the southern side of the new Entrance Reach Channel. Had the submarine followed a trackline of about 100 - 150 feet to the left of buoy 1ER, the large shadow zone on the port side of the *EISENHOWER* prevents a continuous view of a vessel with a low profile or a small vessel, if it passes too close, especially a vessel such as a submarine.
[Ref. 2:p. 21]

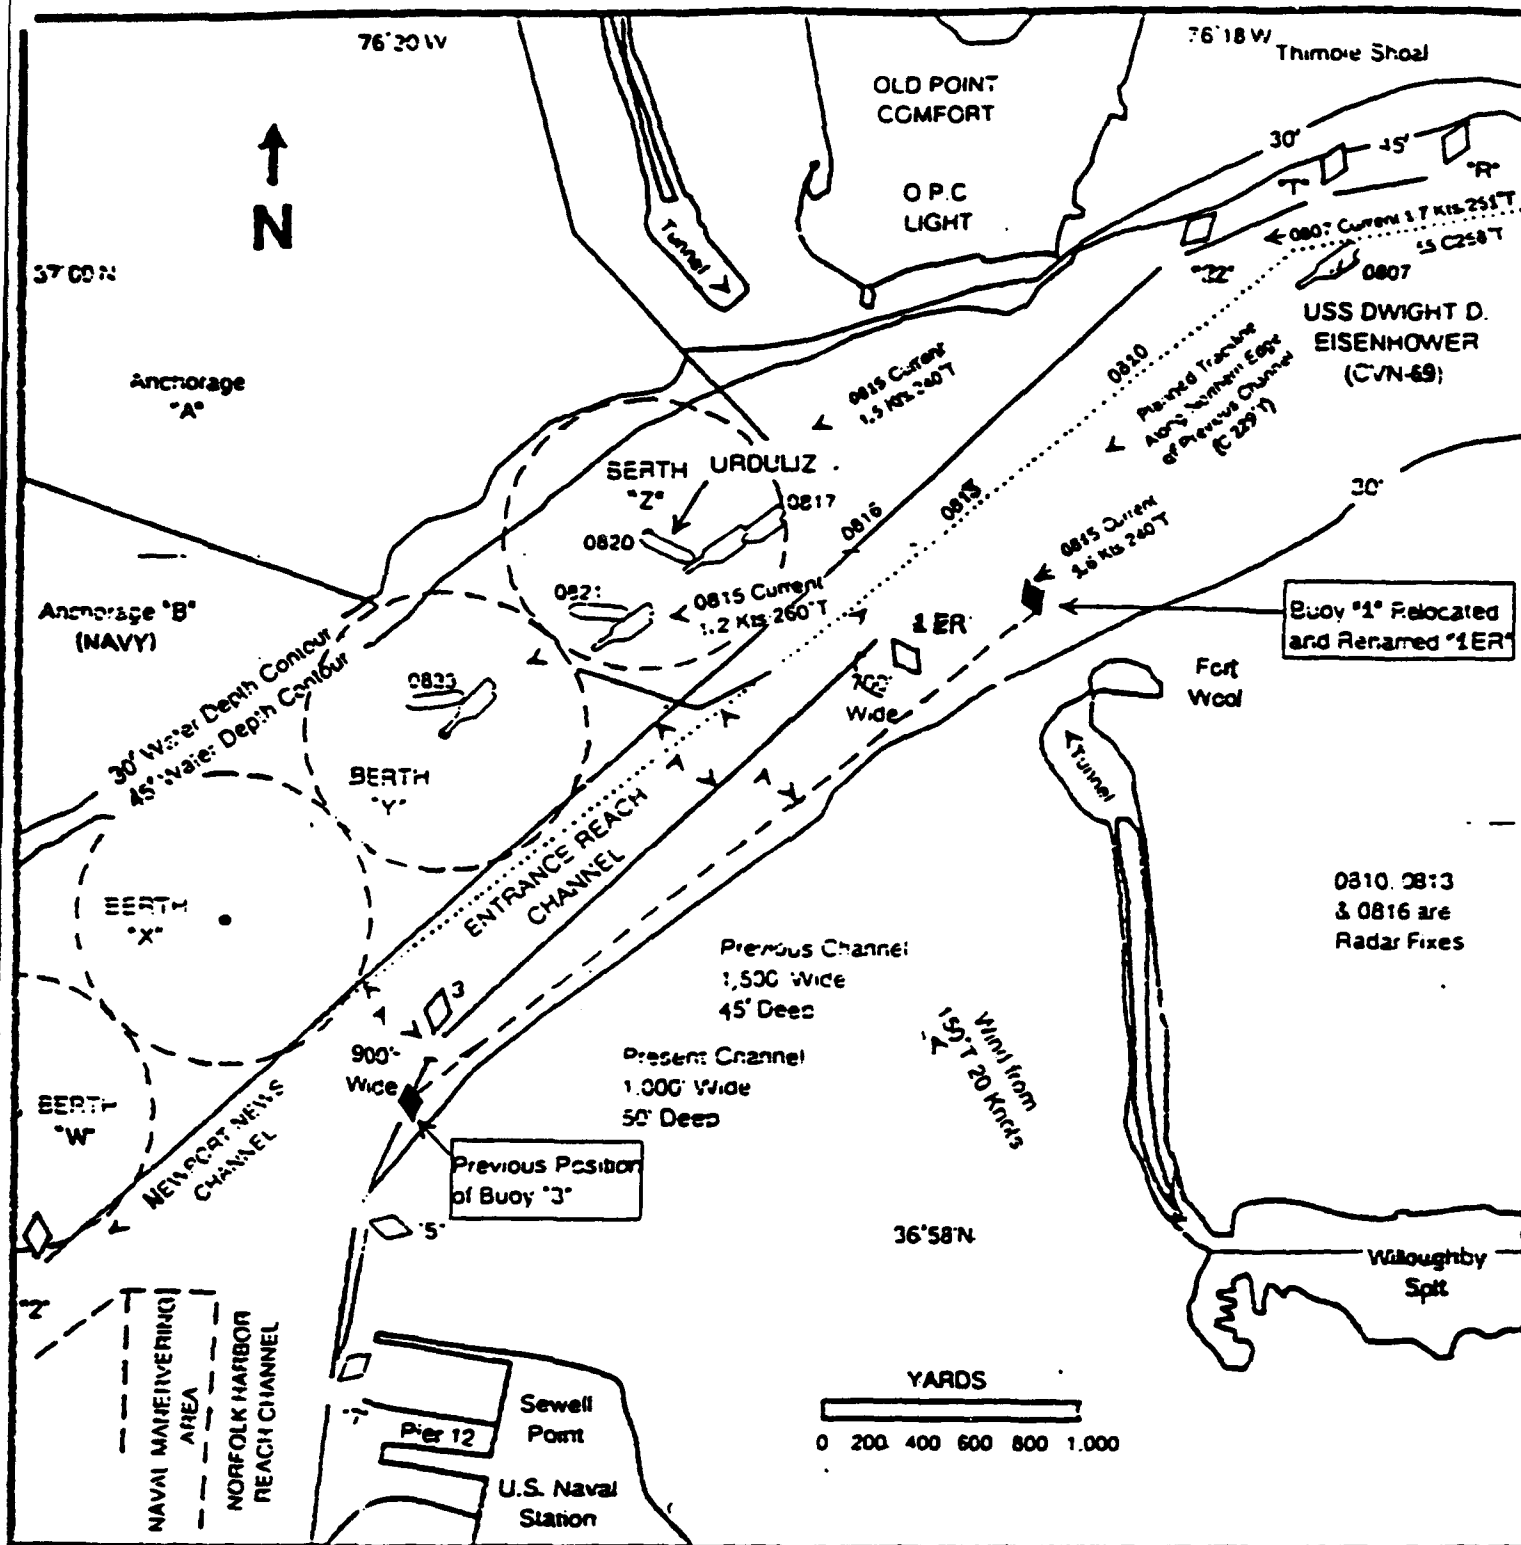
Figure III-3 Detailed chart of the accident site

Entrance Reach Channel is located between Old Point Comfort and Fort Wool on the east and Sewells Point in the west. The southern side of the channel used to be marked with Elizabeth River Channel Lighted Horn Buoy (LHB) "1" (buoy 1) near Fort Wool and the Elizabeth River Channel Lighted Buoy "3" (buoy 3) northwest of Sewells Point (This is depicted in Figure III-3). A line drawn between the two buoys (1 and 3) delineated the southern edge of the channel.

The northern side of the channel was located at the southern edge of Anchorages "A" (berth "Z") and "B" (berths "X", "Y", and "W") and on a line between the Naval Ordnance

Lighted Buoy (buoy "T") east of Old Point Comfort and the Newport News Channel Lighted Buoy "2" (buoy 2). This was a distance of approximately 3.5 nautical miles (nm).

In early 1988, the Thimble Shoal Lighted Buoy "22" (buoy 22) was repositioned close to the eastern side of Old Point Comfort. This created a "hole" in the system; now, there were no buoys between buoy 22 and buoy 2 on the "new" northern side of Entrance Reach Channel, a distance of 3.2 nm. When the Coast Guard was asked why this was permitted, the witness replied, "...when you put buoys near an anchorage, they get run over and they serve only as a hazard to navigation." If an arriving ship followed a course on the northern side of the channel that corresponded to a line drawn between buoys 22 and 2, it would encroach the southern edge of Anchorage "A" and "B", thereby transiting through the anchorage. [Ref. 2:p. 19]

The NTSB also recommended that the Coast Guard "...establish additional buoys on the northern side of Entrance Reach Channel to delineate the channel limits." [Ref. 2:p. 40]
